EOD Improvements Effective April 2005

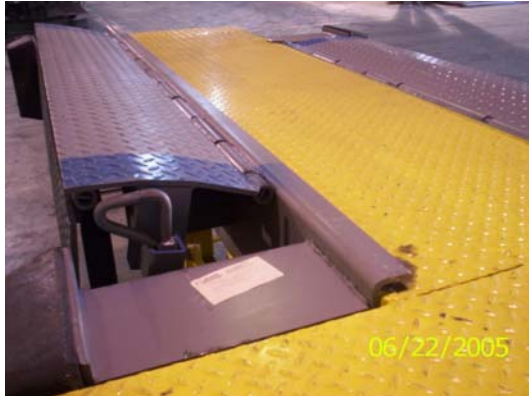
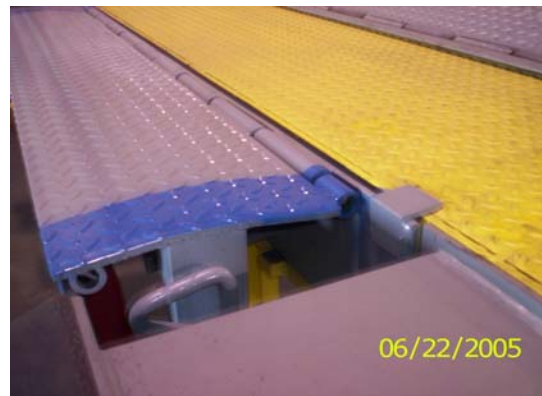
Positioning tabs for proper height at installation

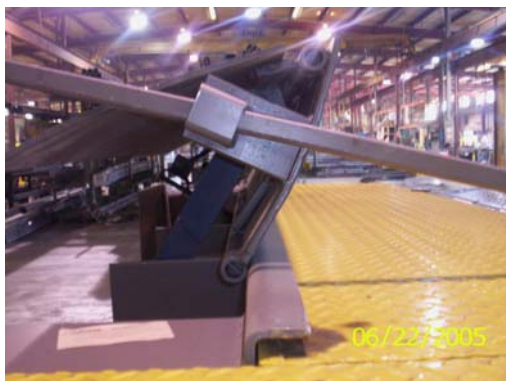
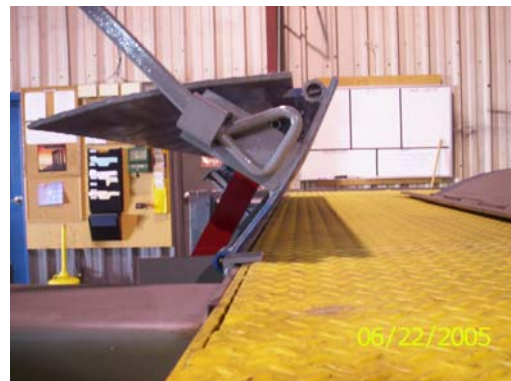
Center-section to hinge tube alignment at mount plate refined to allow further rotation of unit

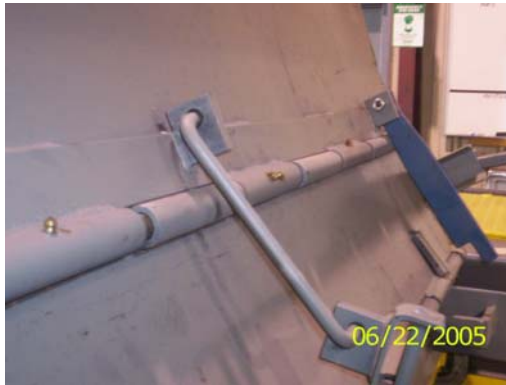
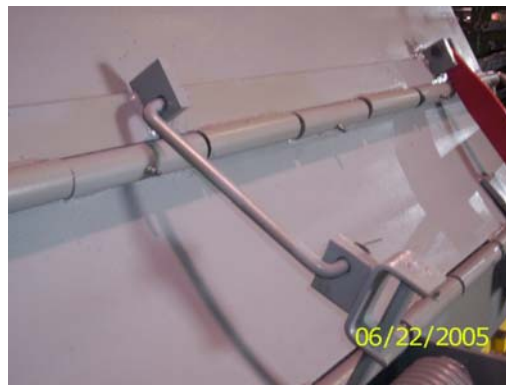
Linkage rod lug on front lip repositioned at customers suggestion reducing overloading of spring

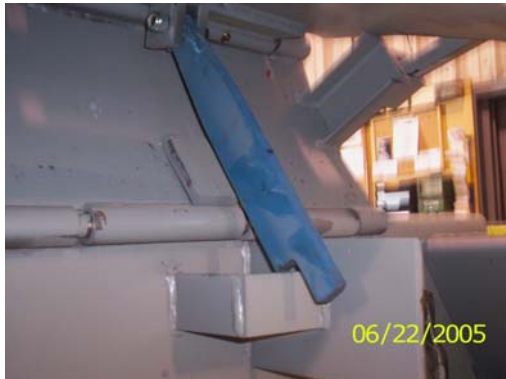
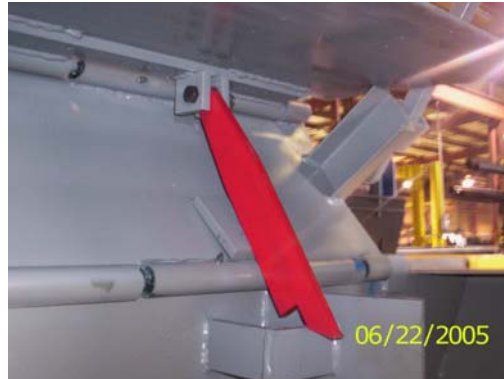
Latch design refined at the suggestion of Chris Pinyan (Weld leadman) to prevent premature kick-off of the latch from the latch catch
